Debris/Ice/TPS Assessment and Integrated Photographic Analysis of Shuttle Mission STS-87

*Process Engineering/Mechanical System Division/ET-SRB Branch,
Kennedy Space Center, Florida*

**DEBRIS/ICE/TPS ASSESSMENT
AND
INTEGRATED PHOTOGRAPHIC ANALYSIS
OF
SHUTTLE MISSION STS-87**

19 November 1997

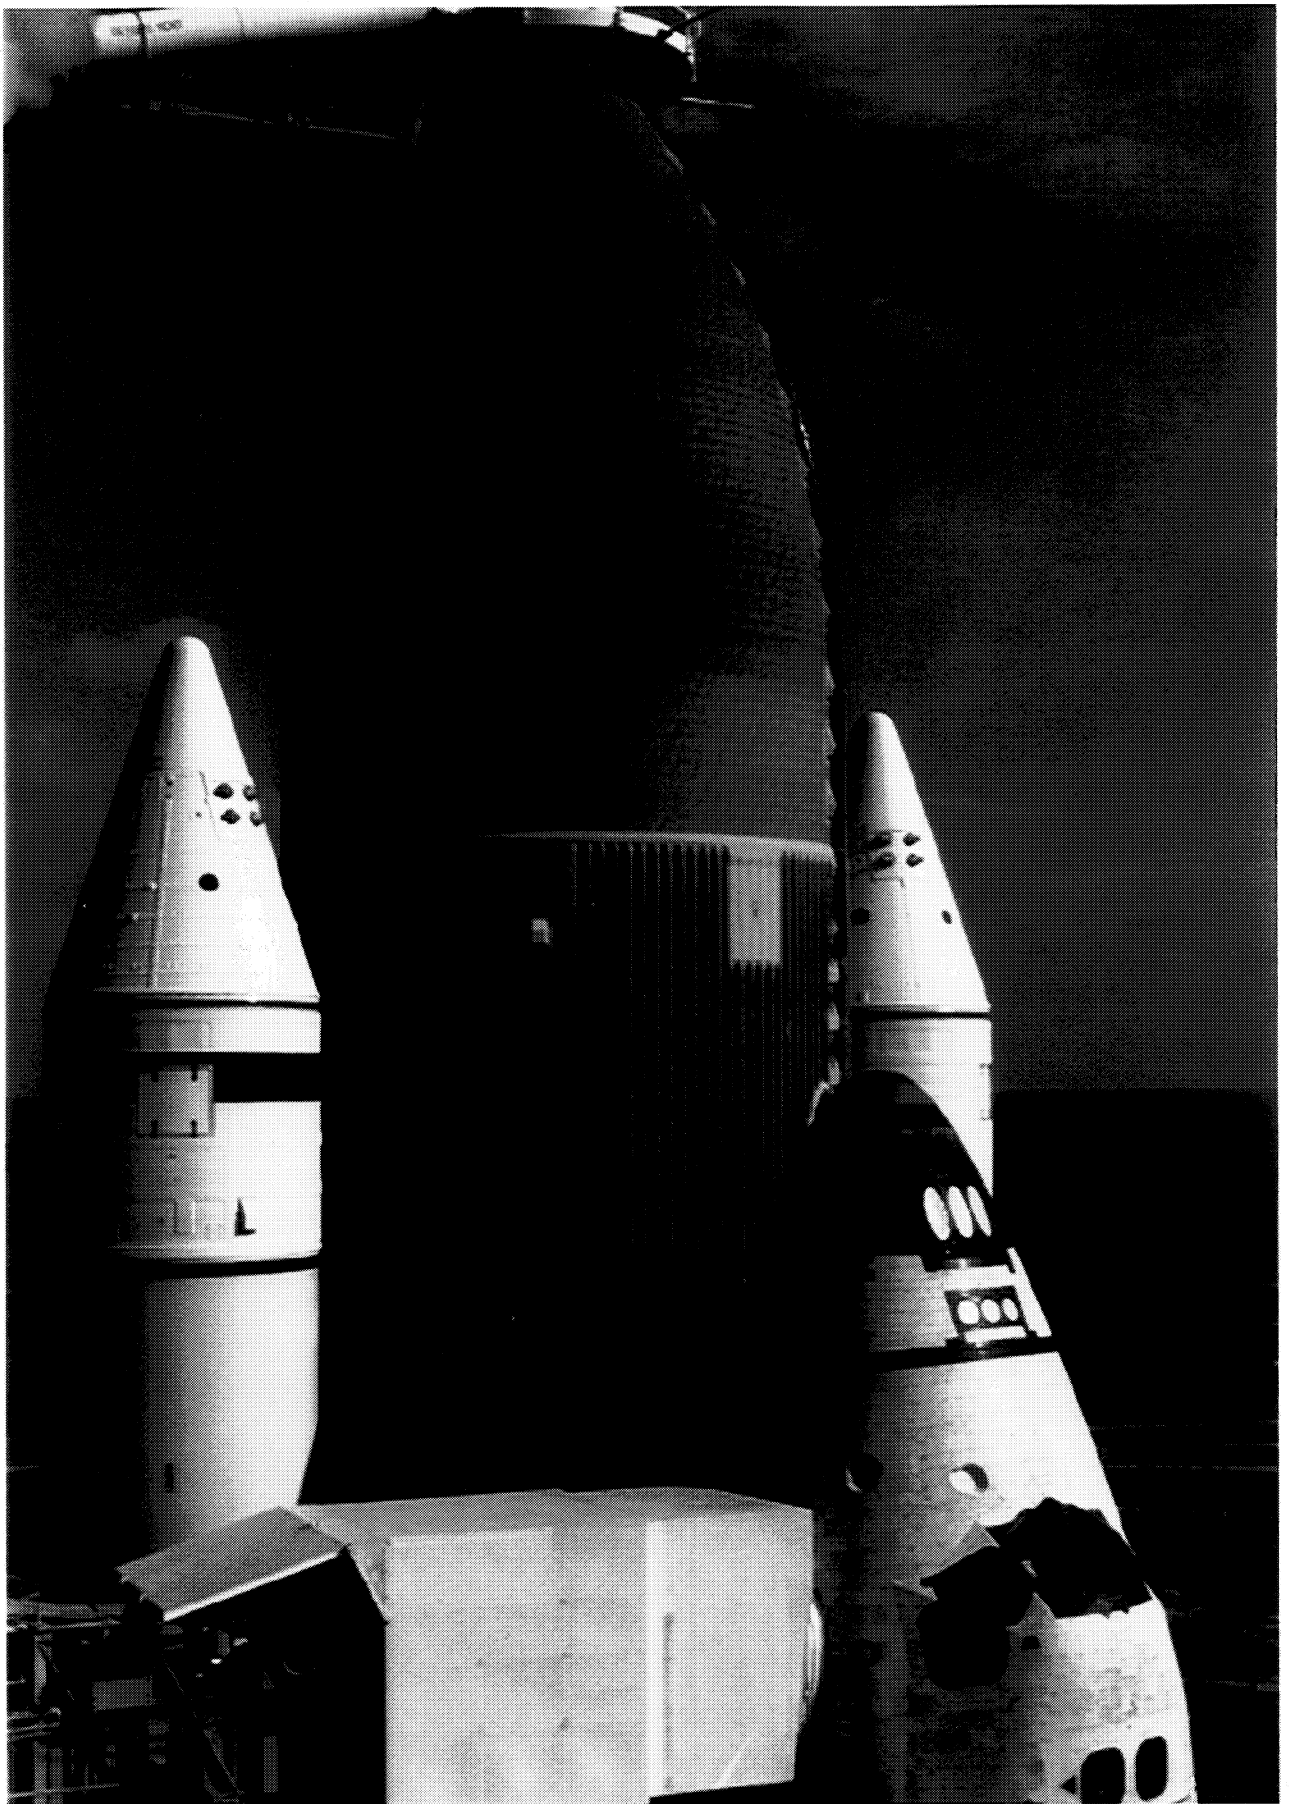
Photo 3: LO2 Tank After Cryoload

The Final Inspection Team observed light condensate, but no ice or frost accumulations, on the LO2 tank acreage. TPS surface temperatures ranged from 53 to 57 degrees F. No damage to either -Y or +Y ET intertank thrust panel TPS was observed prior to launch.

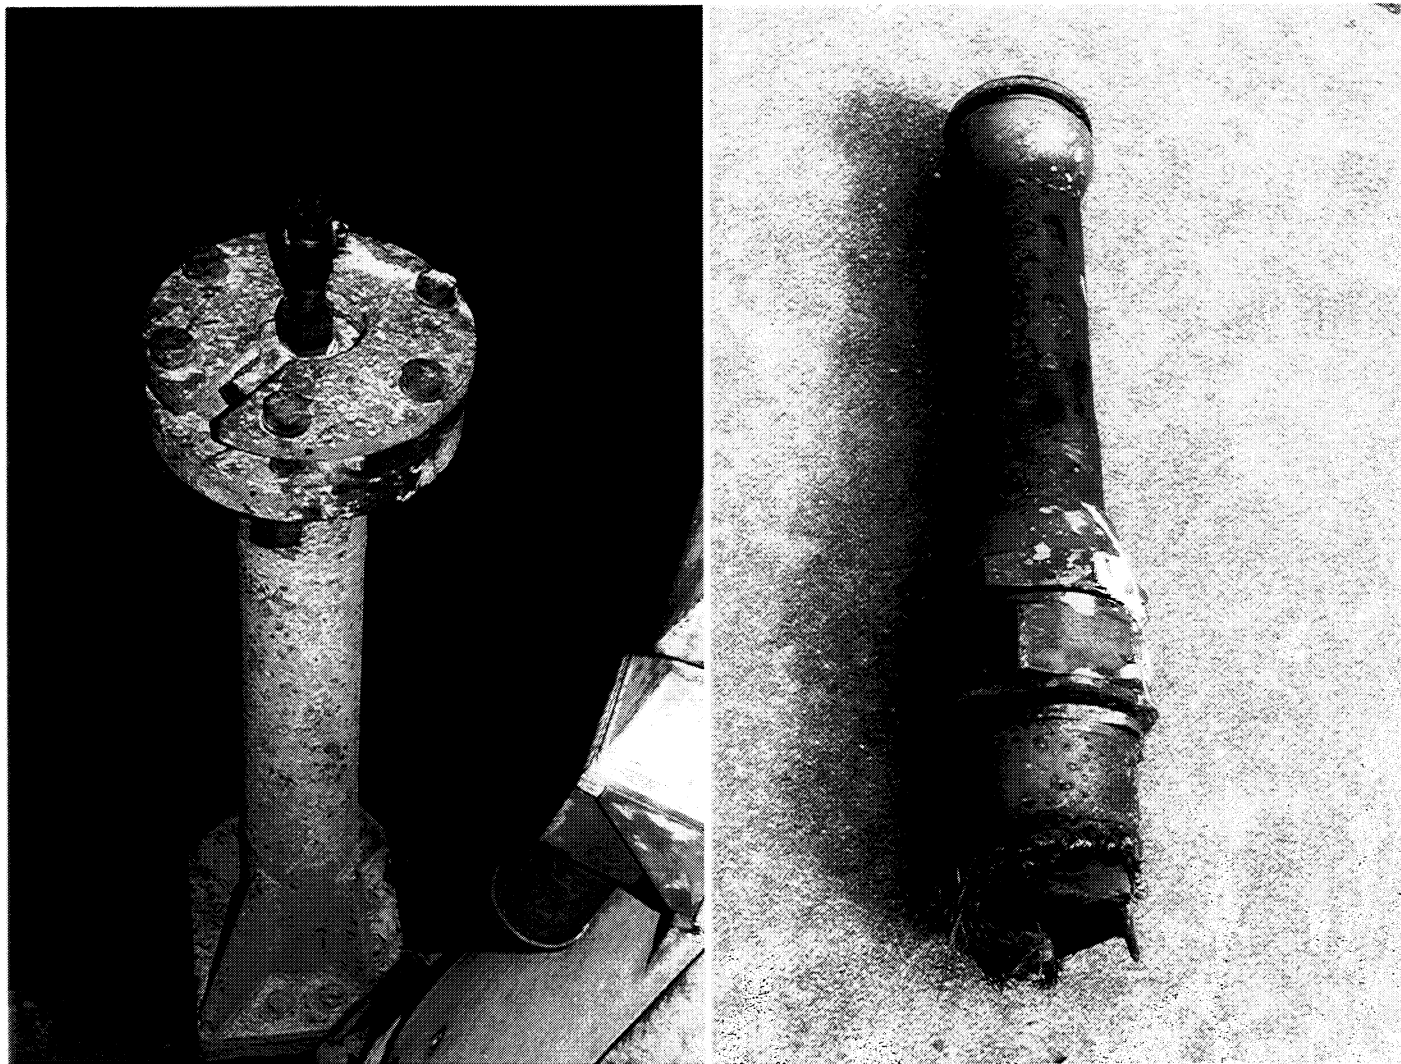
Both left and right SRB aft skirt GN2 purge lines (P/N 10185-0018-101) were missing approximately 12 inches of tube and flex-line. Typically, the purge lines are bent or deformed by SRB exhaust plume impingement. This was the first occurrence of missing hardware and was considered to be an "out-of-family" condition (PR PV6332972/D-BI-092L-0003). The remaining, or lower, part of the line was still attached to the MLP GN2 standpipe supporting structure adjacent to holddown posts #2 and #6. The right flex-line was recovered in an area just north of the SRB flame trench. This flex-line measured 10.5-inches long by 2.25-inches maximum width. The left flex-line was subsequently discovered on or near a holddown post haunch during MLP refurbishment operations. All four rigid components of the GN2 purge lines were recovered, though approximately 90 percent of the stainless steel braided portion of the flex-line was not recovered.

Analysis of the recovered components revealed a failure due to the effects of heat damage (melting) from SRB exhaust plume impingement and led the investigation team to conclude the design capability did not withstand the thermal environment. As a result, the GN2 purge line will be redesigned.

Photo 5: SRB Aft Skirt GN2 Purge Lines

Both left and right SRB aft skirt GN2 purge lines were missing approximately 12 inches of tube and flex-line. Typically, the purge lines are bent or deformed by SRB exhaust plume impingement. This was the first occurrence of missing hardware and was considered to be an “out-of-family” condition. The remaining, or lower, part of the line was still attached to the MLP GN2 standpipe supporting structure adjacent to holddown posts #2 and #6 (left photo). The right flex-line was recovered in an area just north of the SRB flame trench. This flex-line measured 10.5-inches long by 2.25-inches maximum width (right photo). The left flex-line was subsequently discovered on or near a holddown post haunch during MLP refurbishment operations.

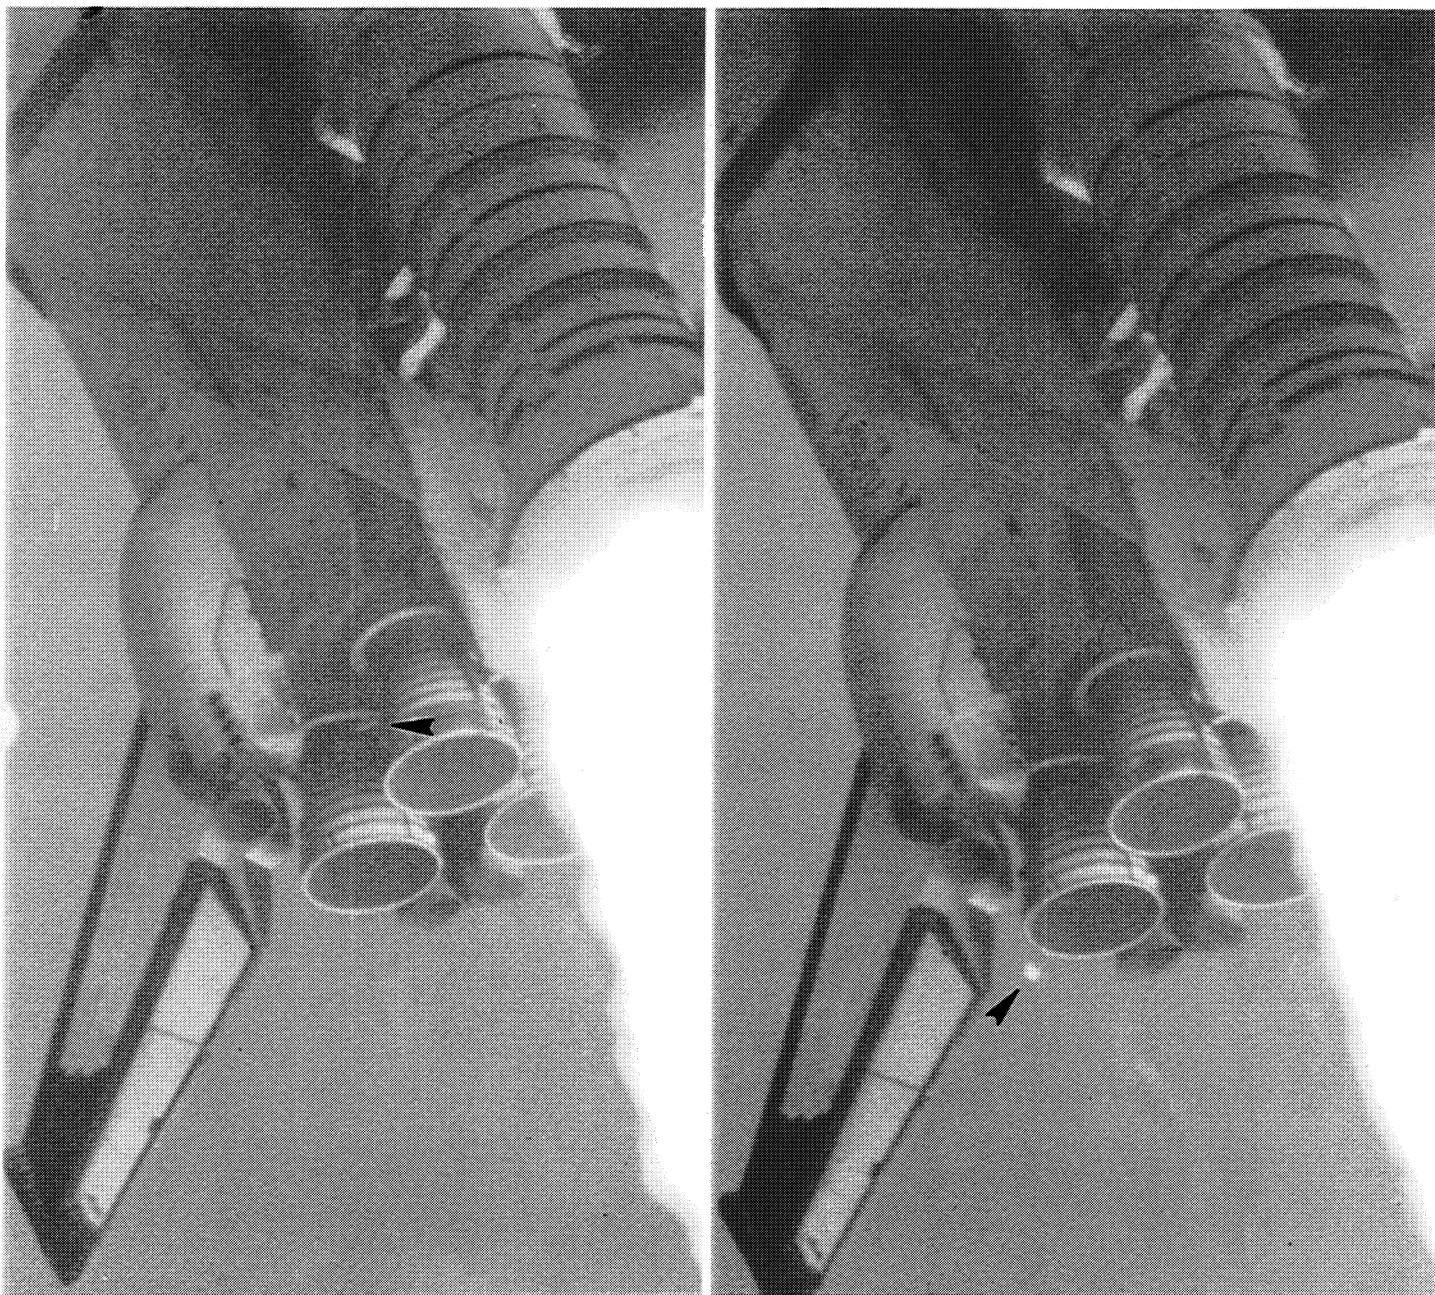
Photo 6: SSME Heat Shield Blanket

Film item E-207 and video item ET-207 provided the best views of a Dome Mounted Heat Shield (DMHS) closeout blanket at the 5:00 o'clock position of SSME #1 starting to tear and unstitch at $T + 20.5$ seconds MET (left photo). Air flow and plume recirculation eventually caused the blanket to come loose at $T + 38.5$ seconds MET. The blanket appeared to be lifted in the +Z direction and passed between the SSME #1 nozzle and the drag chute door before falling aft (right photo).

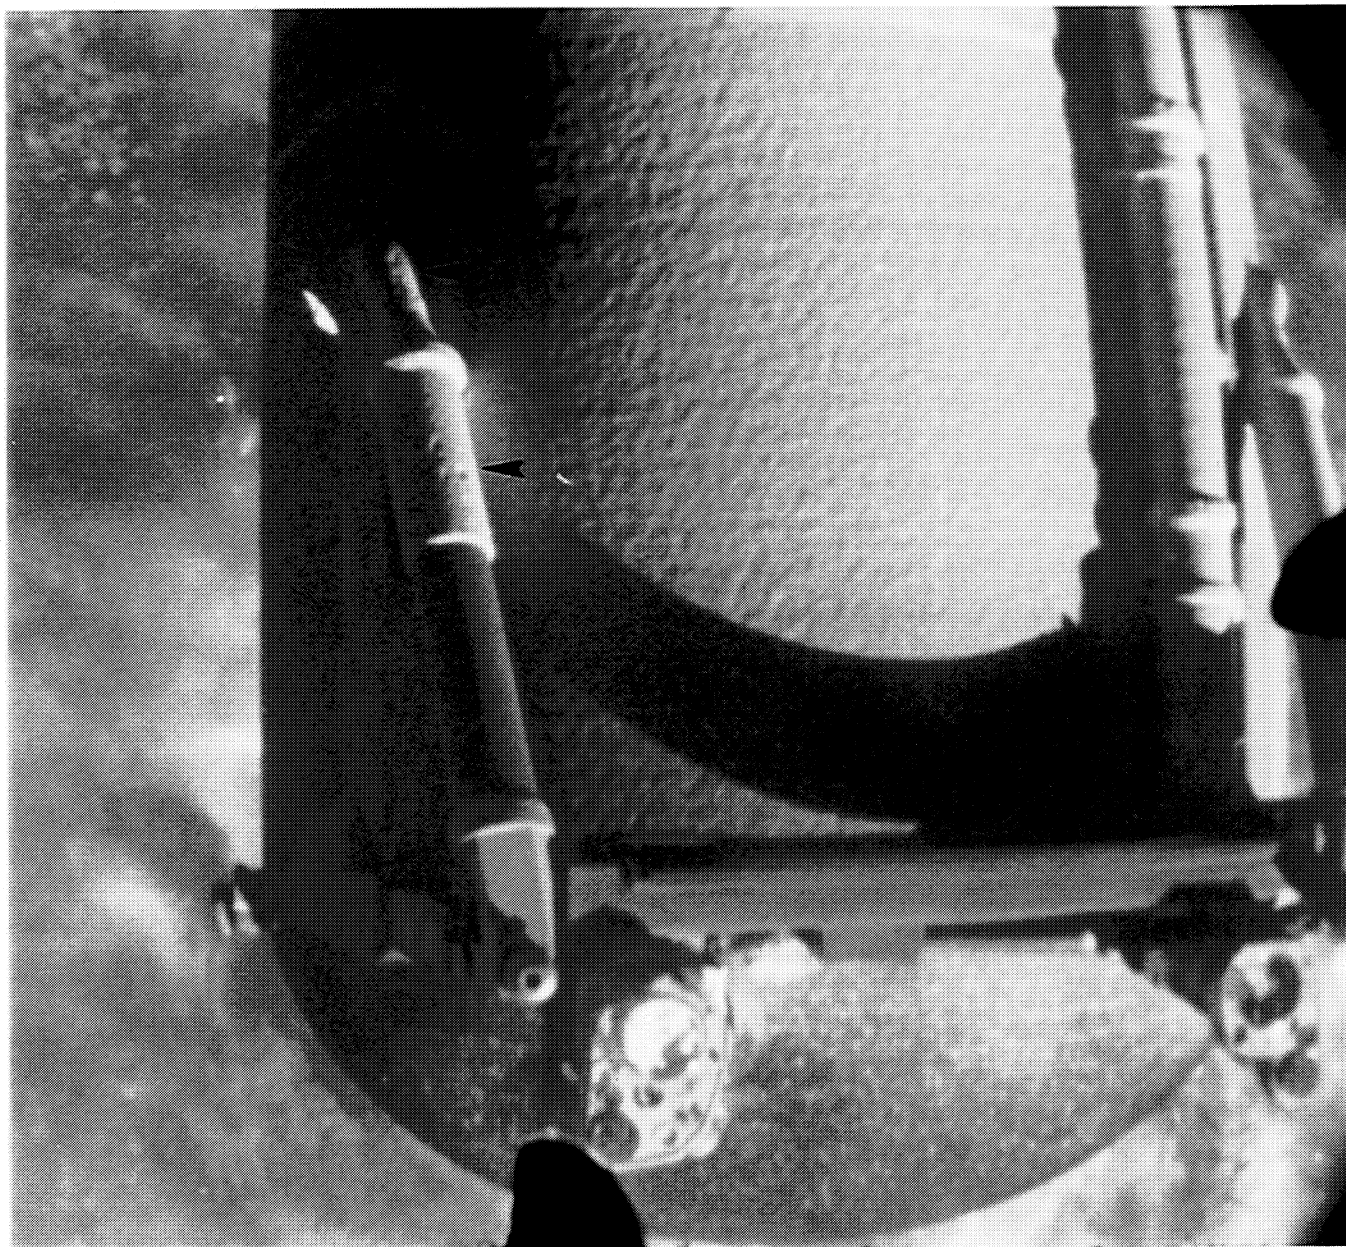
Photo 8: ET Separation from Orbiter

ET-89 separation from the Orbiter was normal. Foam on both thrust struts exhibited damage. Eight divots were detected on the -Y thrust strut and flange closeout. Some of these divots were fore-to-aft gouges and gave the appearance of being caused by debris impacts.

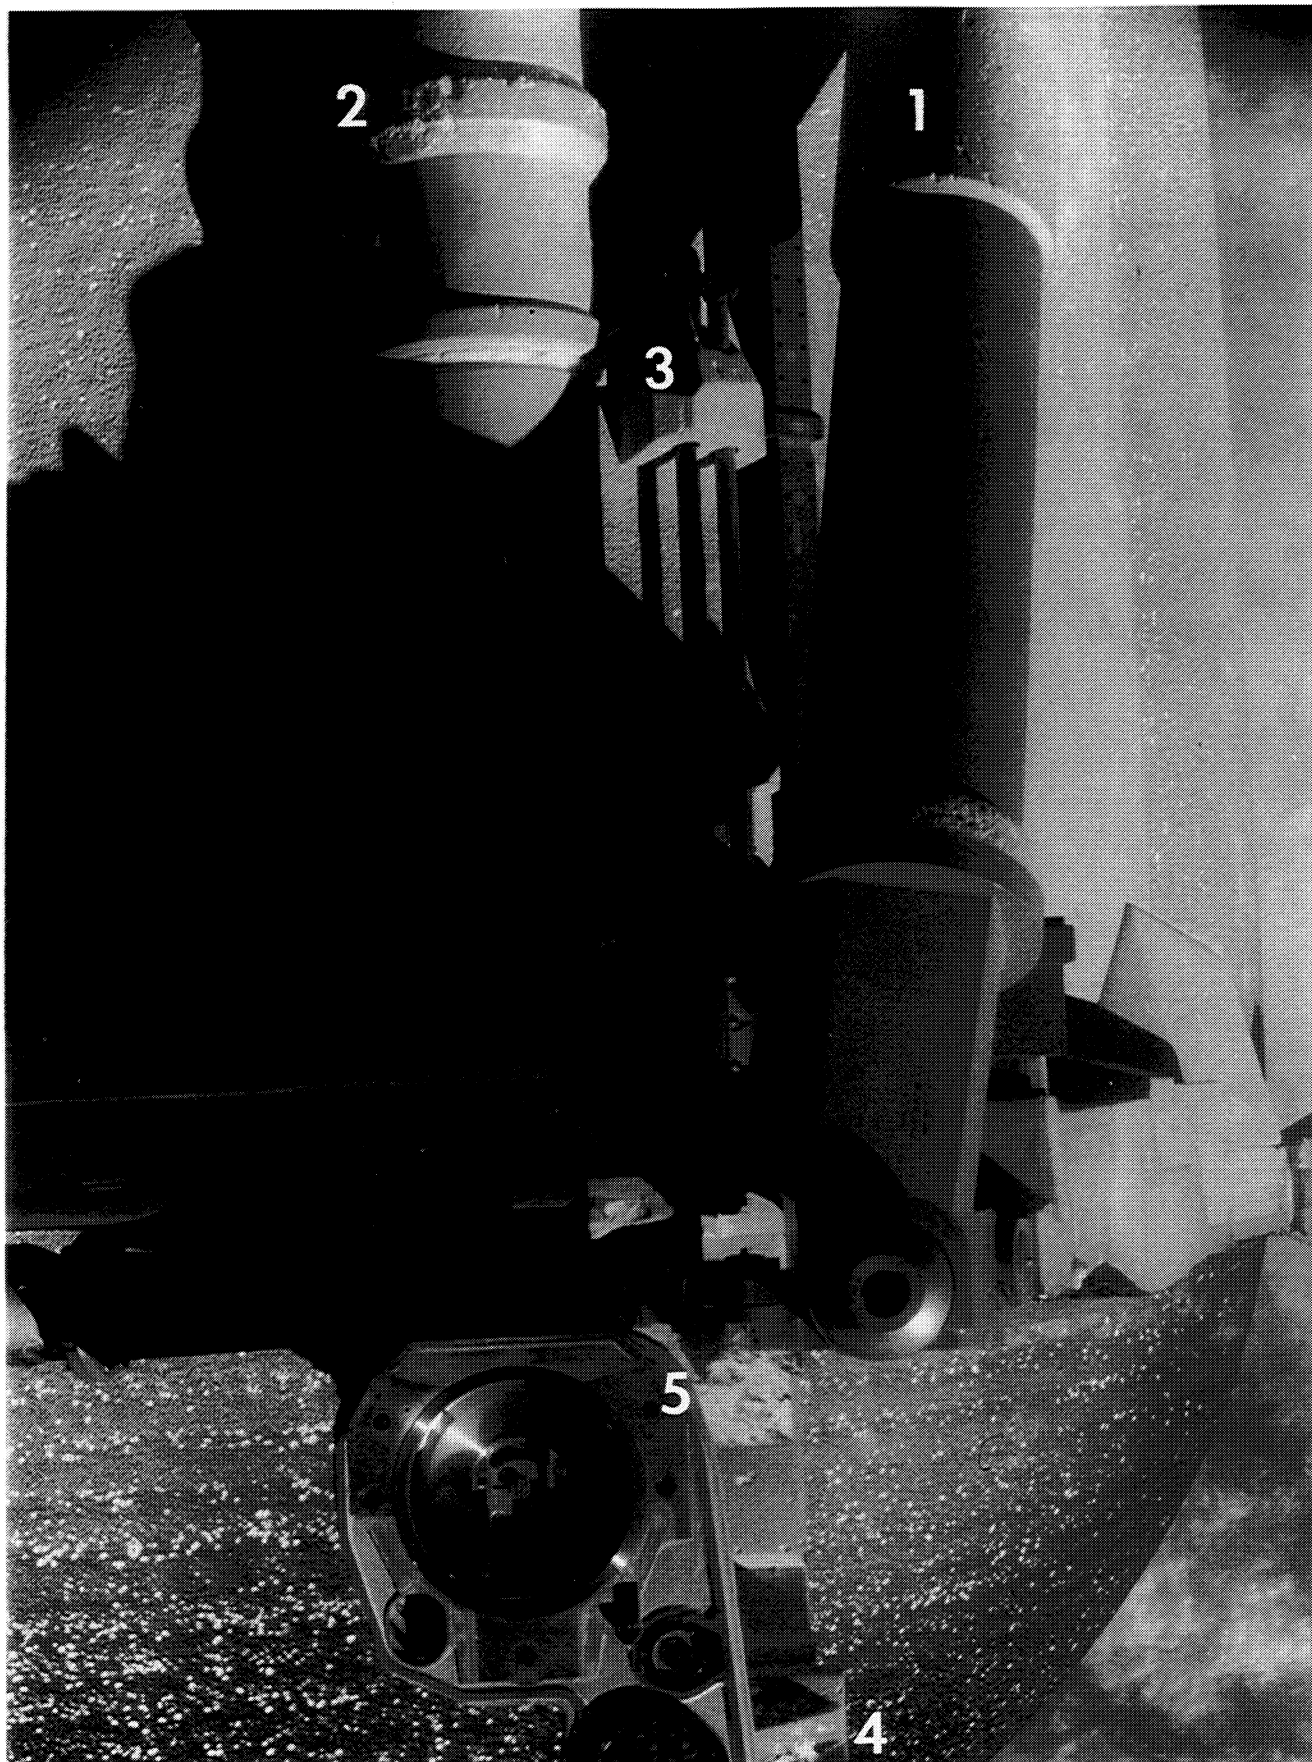
Photo 9: View from 35mm Umbilical Camera

Impact-type damage and fore-to-aft gouges were present in the TPS on the +Y thrust strut (1), LO2 feedline flange closeouts (2), and the pressurization line ramps (3). The LO2 ET/ORB umbilical appeared to be undamaged, though erosion and divots were visible in the horizontal (4) and vertical (5) sections of the cable tray. "Popcorn" type divots were greater in number on the aft dome and the lower LH2 tank acreage - an expected occurrence with the new (NCFI) foam.

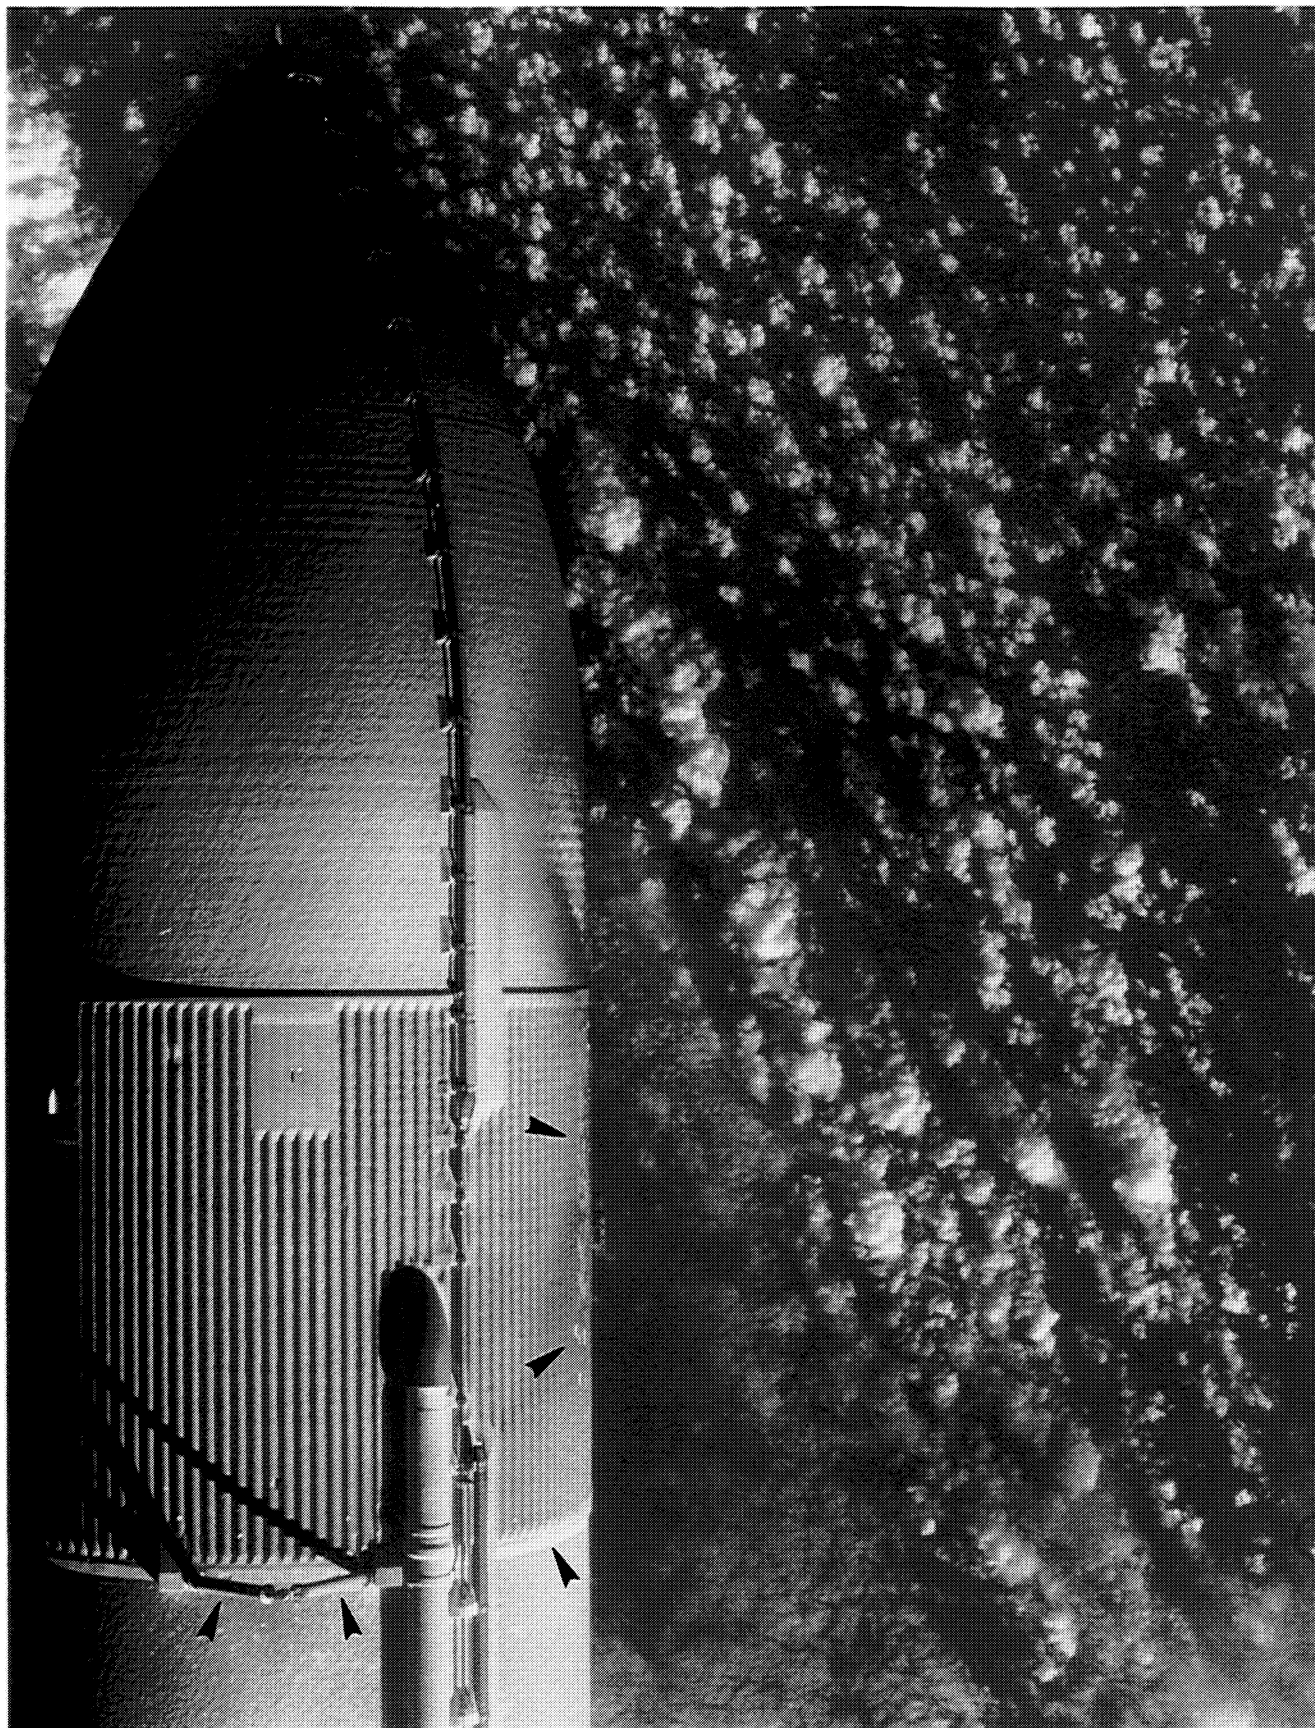
Photo 10: Thrust Panel Foam Damage

The bipod jack pad standoff closeouts were intact. However, numerous divots were visible in the +Y thrust panel TPS forward and aft of the ET/SRB forward attach point (the -Y thrust panel was in shadow and therefore not visible). One 8-inch diameter divot was detected in the LH2 tank-to-intertank flange closeout between the +Y thrust panel and the LO2 feedline. The BSM burn scar on the LO2 tank was typical.

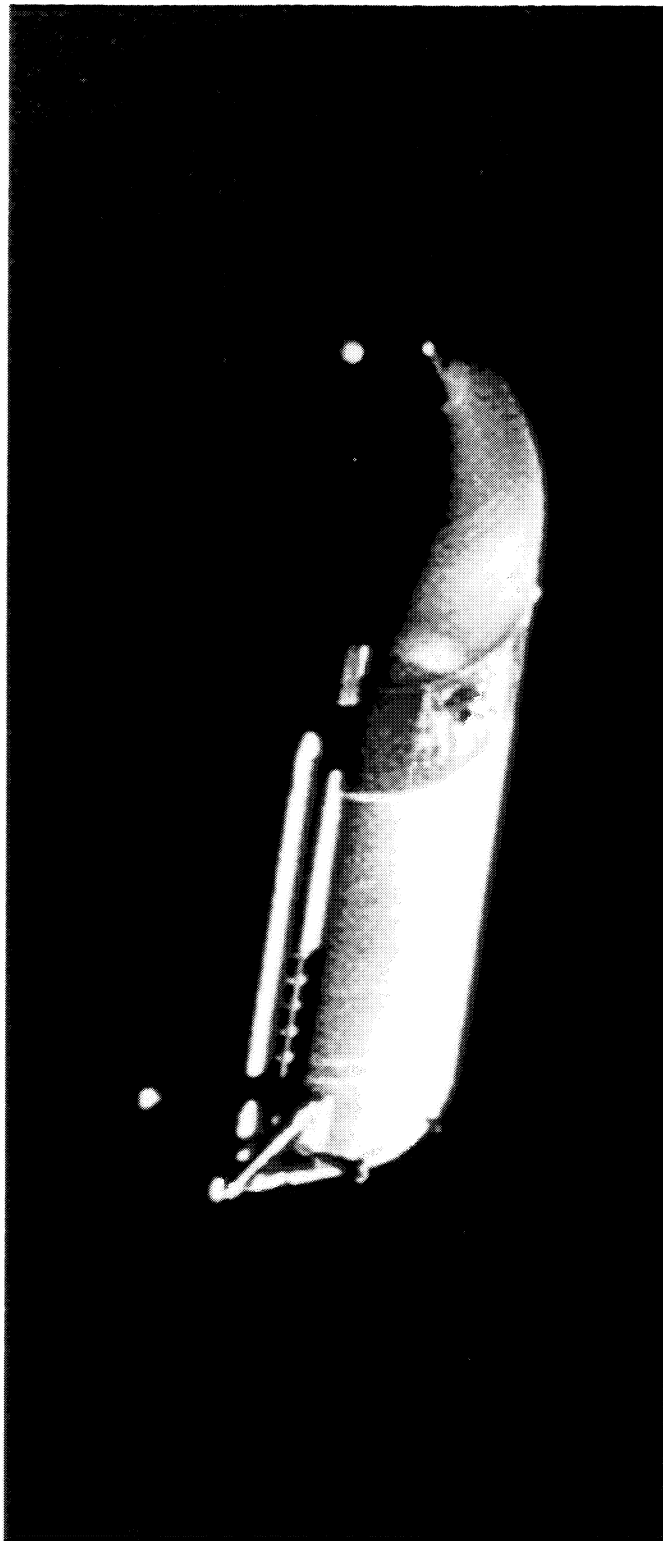
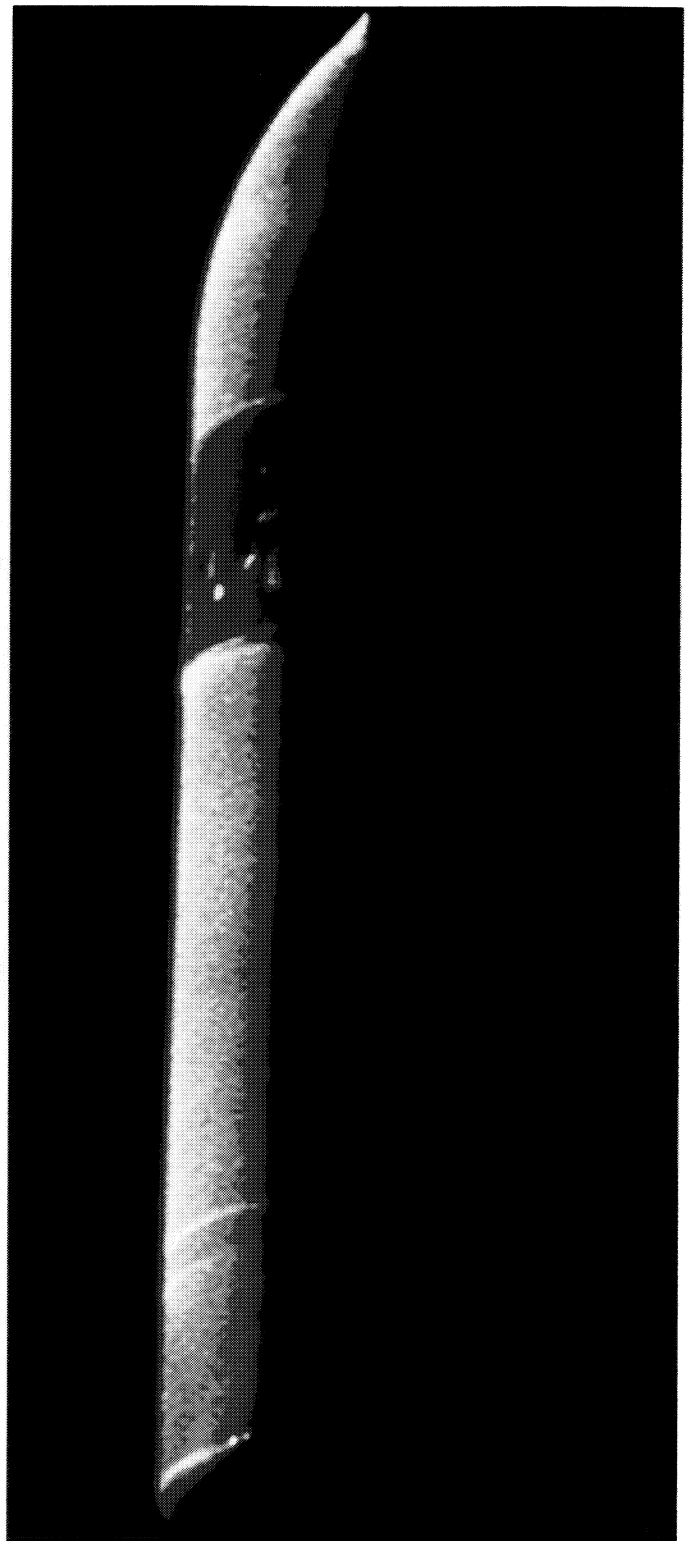
Photo 11: Crew Hand-Held Still Images

Still images of the ET after separation from the Orbiter were obtained by the crew using the 70mm camera. The ET was approximately 1.1 kilometers away when the first still frame was taken. These images showed conclusive proof that substantial amounts of TPS were missing from both ET thrust panels forward and aft of the ET/SRB attach fittings.

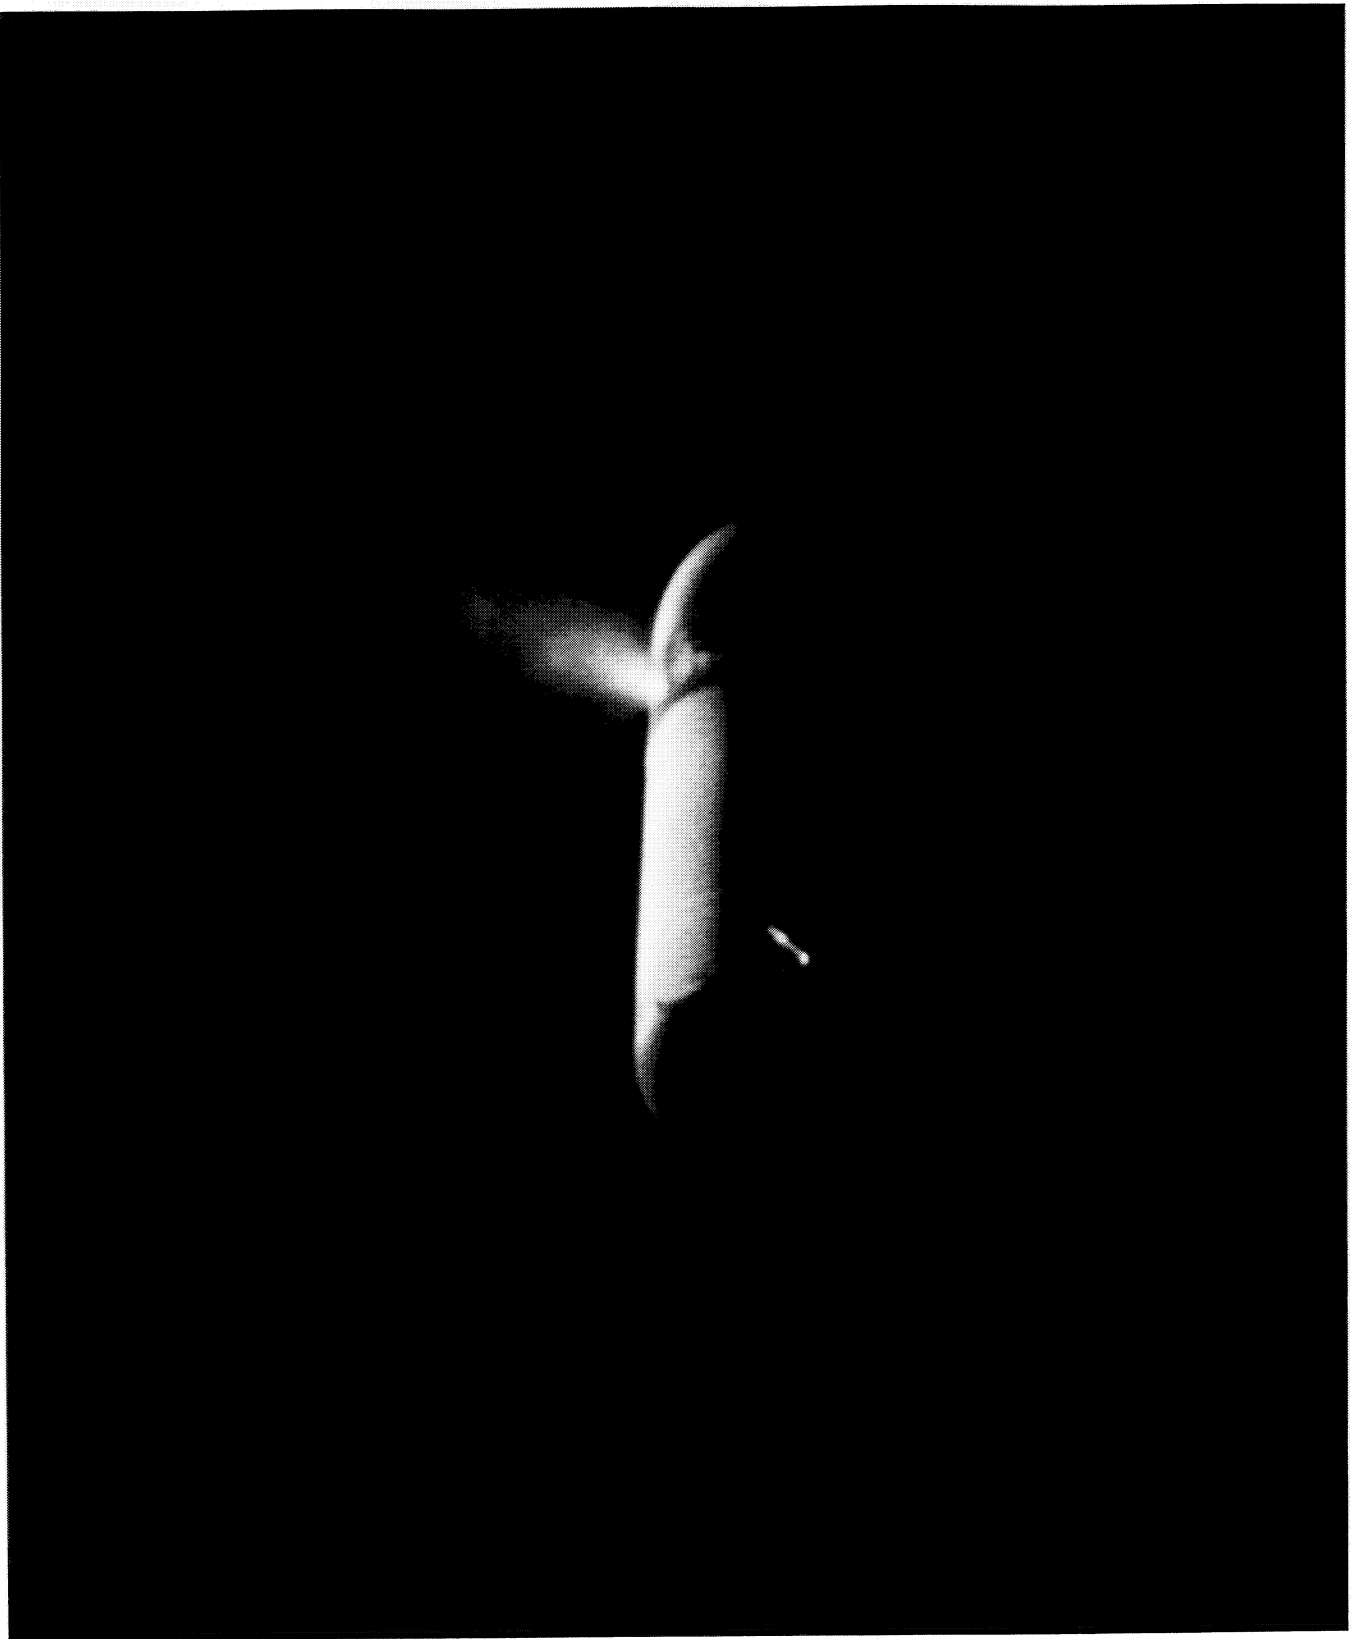
Photo 12: Gaseous Hydrogen Venting

A rarely seen view of gaseous hydrogen venting from the 7-inch QD in the intertank. Venting from this location had been observed only once before on STS-45. Since the venting was not visible in the 16mm ET/ORB umbilical films (distance of 200+ feet and time of 49 seconds after separation), this event and any associated debris were judged to have no affect on the Orbiter or be associated with any tile damage. The venting itself is not considered anomalous. Note damage to TPS on nearby intertank thrust panel.

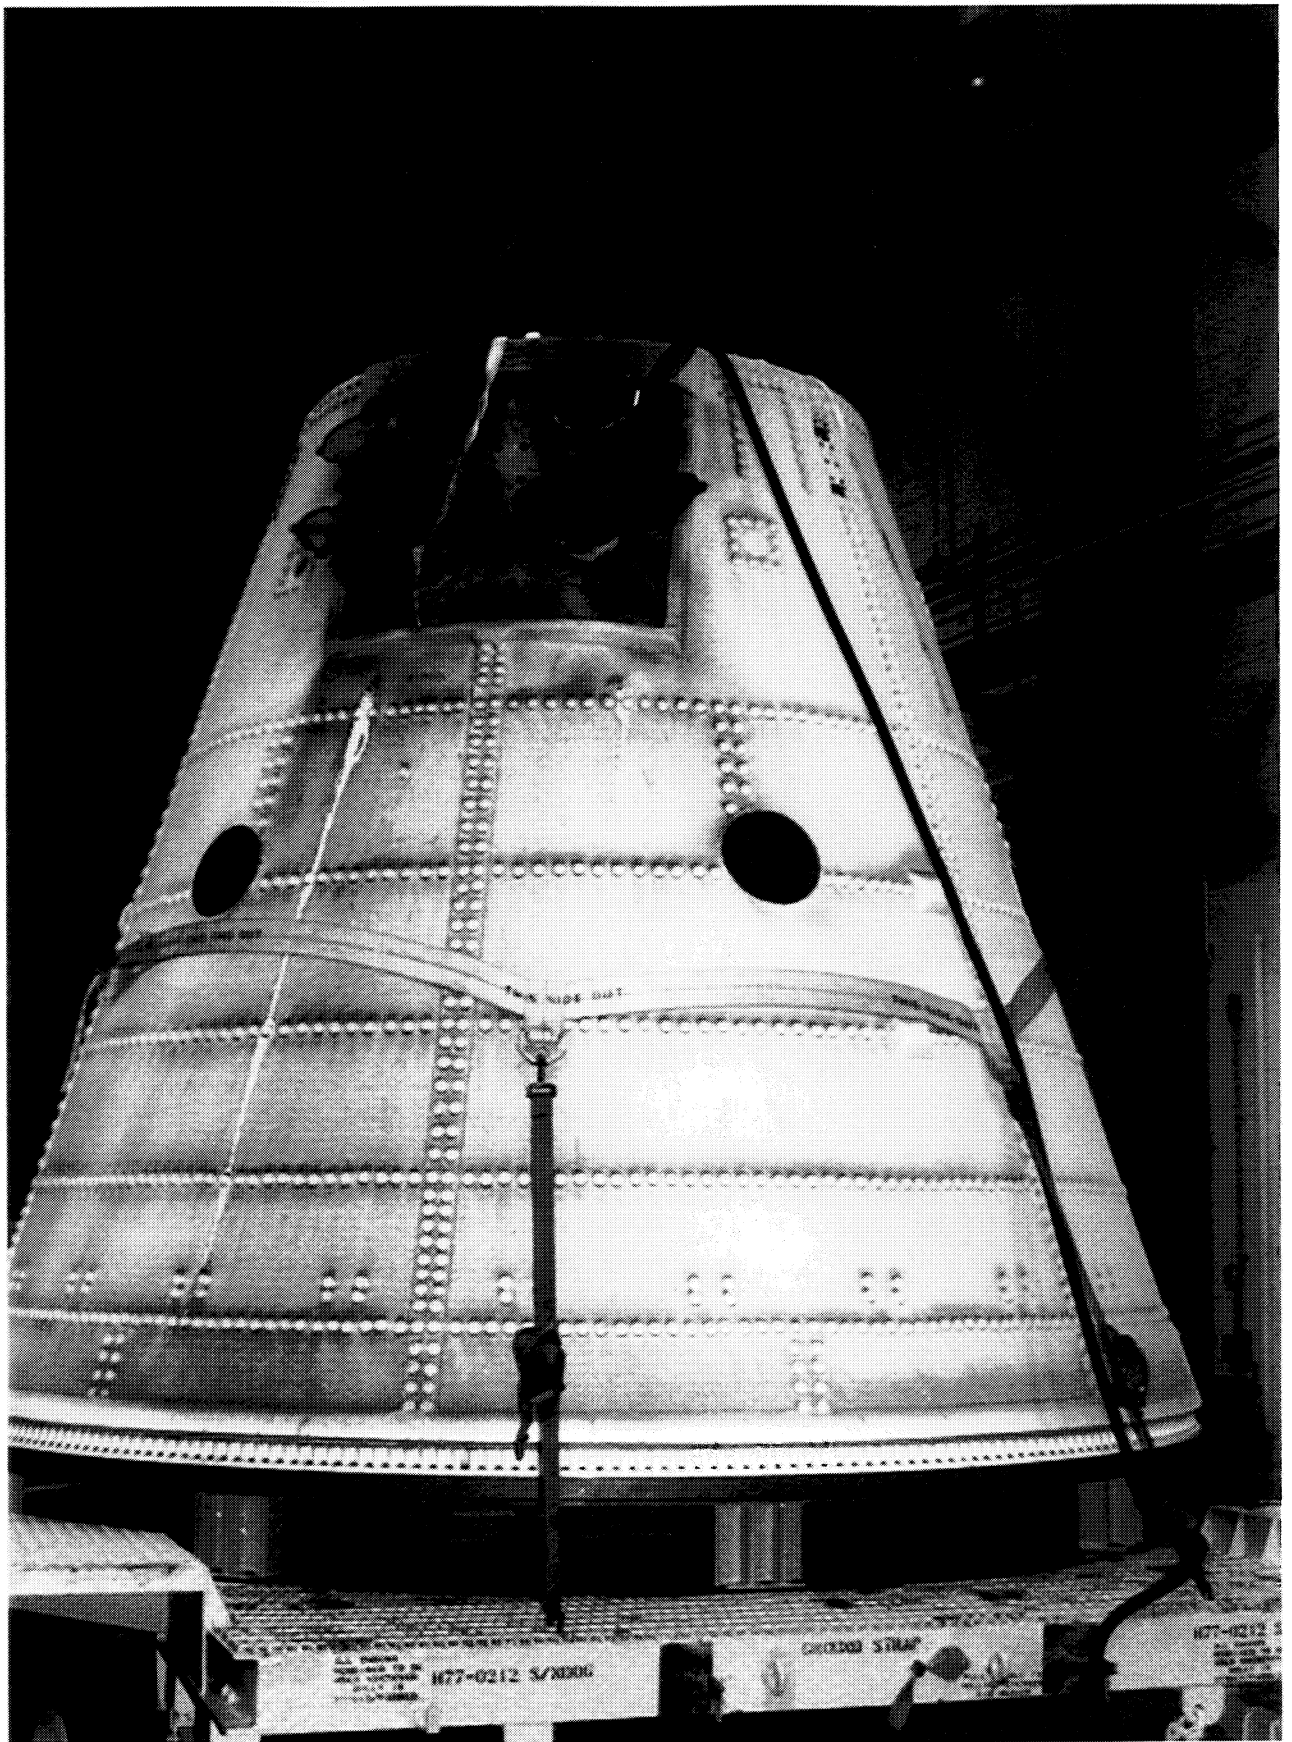
Photo 13: Frustum Post Flight Condition

Both frustums were in excellent condition. No TPS was missing and no debonds/unbonds were detected over fasteners. Virtually none of the Hypalon paint had blistered. All eight BSM aero heat shield covers had locked in the fully opened position though the attach rings on three of the four covers on the left frustum had been bent to varying degrees by parachute riser entanglement.

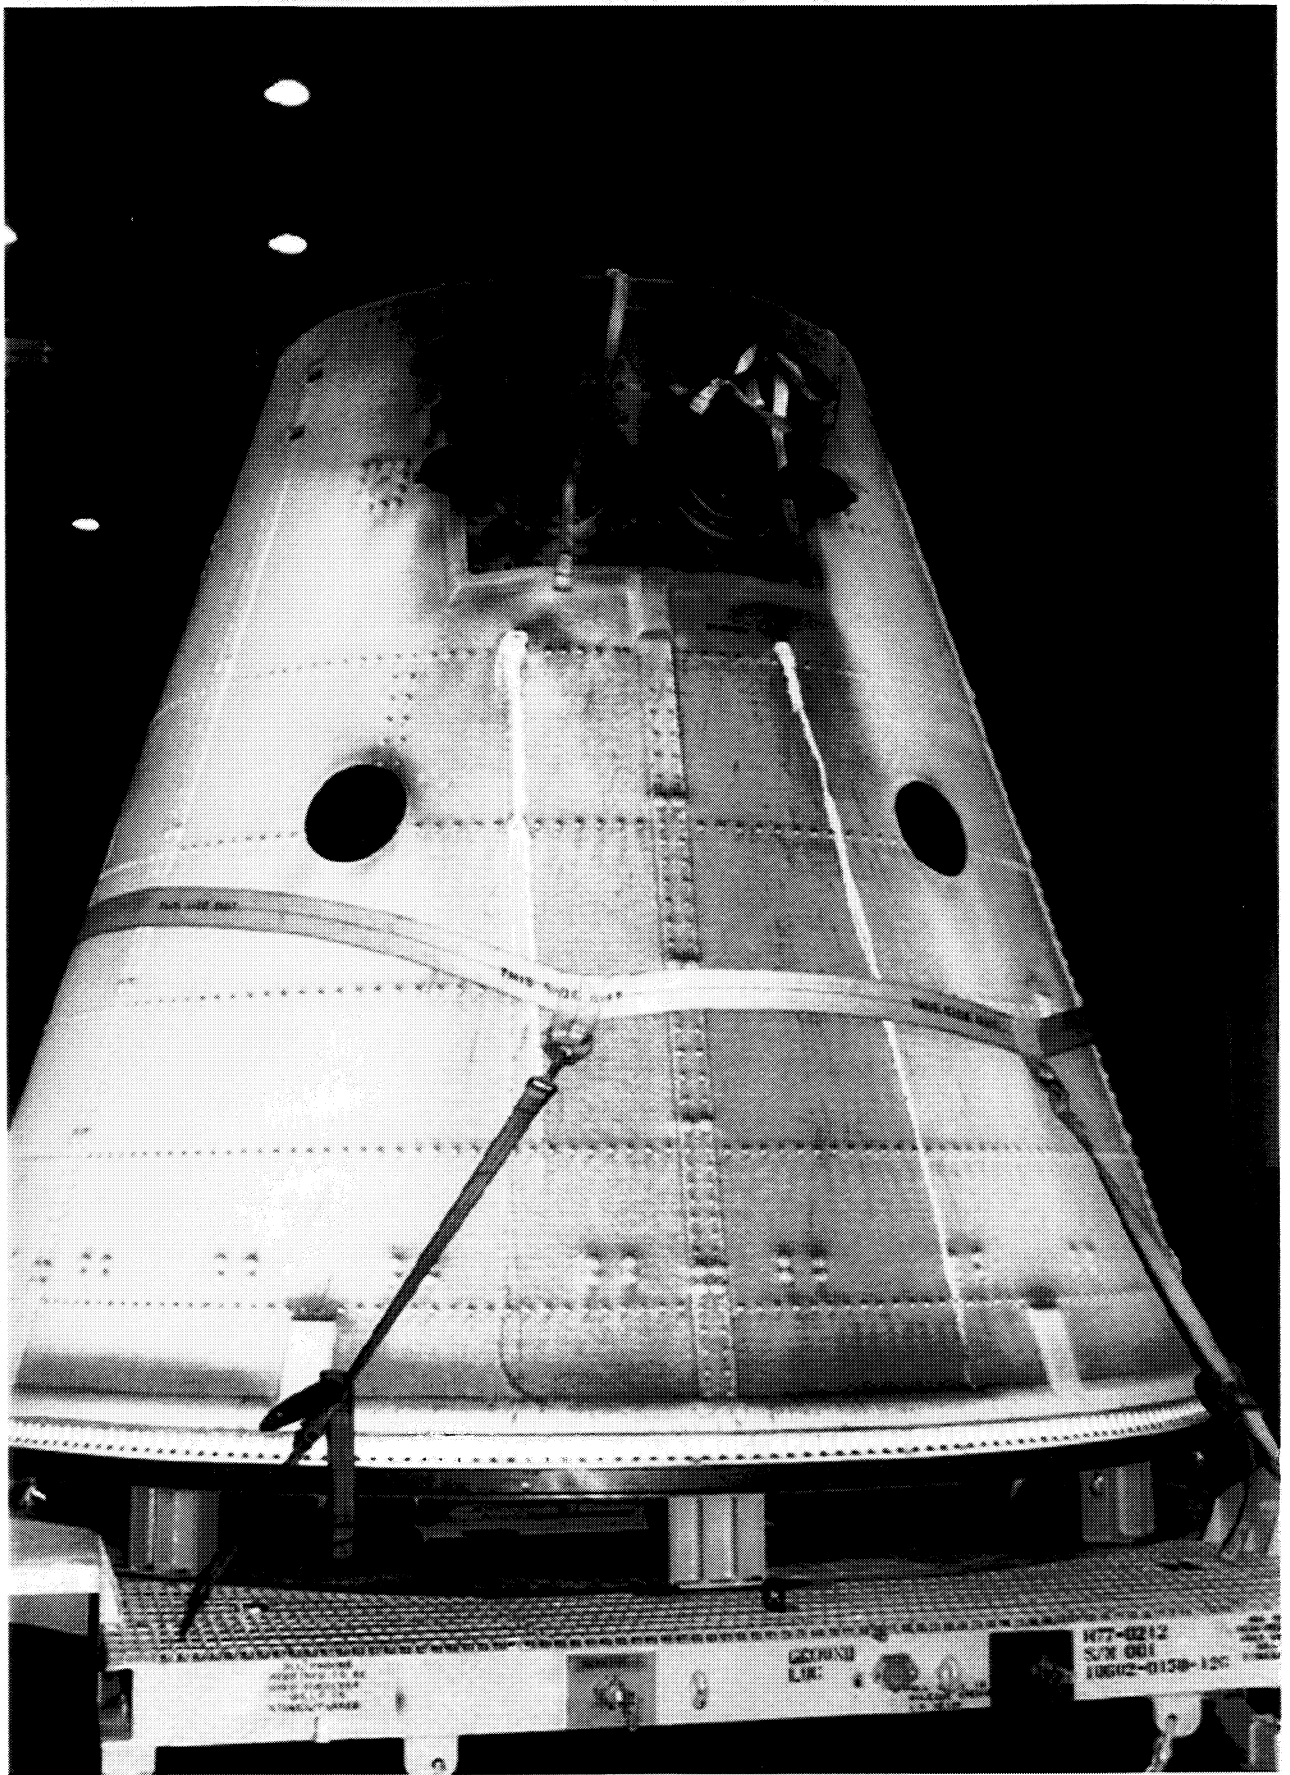
Photo 14: Frustum Configuration Change

A configuration change had been made to the right frustum. The PR-1422 sealant/cap closeouts had been eliminated from the majority of the fastener heads prior to the application of ablator. There were no debonds, unbonds, or missing TPS associated with this change.
